Update "With-Site-Visit" Reserve Study

Leisure World Seal Beach Mutual 5 Seal Beach, CA

Report #: 21575-8
For Period Beginning: January 1, 2020
Expires: December 31, 2020

Date Prepared: August 22, 2019

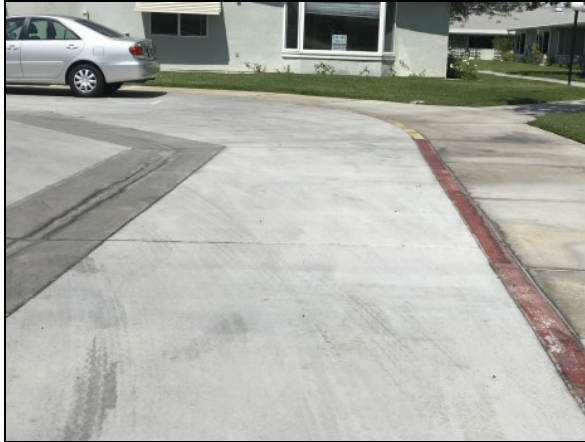
Comments: Generally a lifetime component, however, sectional repair or replacement will be required over time. Monitor for cracking, shifting and uneven surfaces which may cause trip hazards.

Allowance for major repair

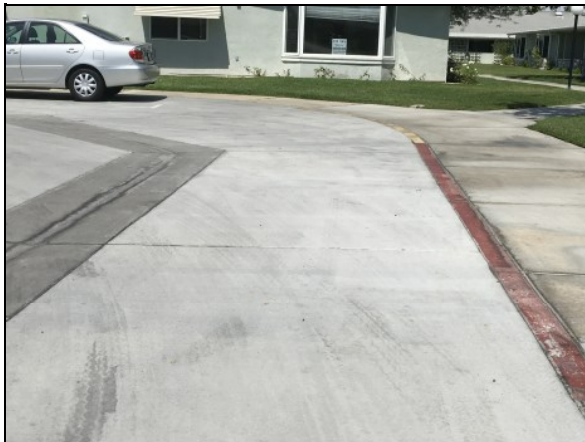
Comments: Generally a lifetime component, however, sectional repair or replacement will be required over time. Monitor for cracking, shifting and uneven surfaces which may cause trip hazards.
